**Construction Management of the Jordan School Expansion Project (JSEP)
and the Schools for a Knowledge Economy Project (SKEP)**

Site Visit Report Form

FTR # QR236

Program (JSEP or SKEP): SKEP **PHASE :** III **PACKAGE:** 2
School Name: Hai Al Iskan Basic Mixed School
Supervisory Engineer (SE) Name: Wahib Medanat Consultant Engineers
Construction Contractor (CC) Name: Dijlah Establishment Contracting Co.
Date and Time of Field Trip: December 08, 2020
Date of Report: December 11, 2020
Weather During Visit Sunny
Report Submitted By: Osama Obeid

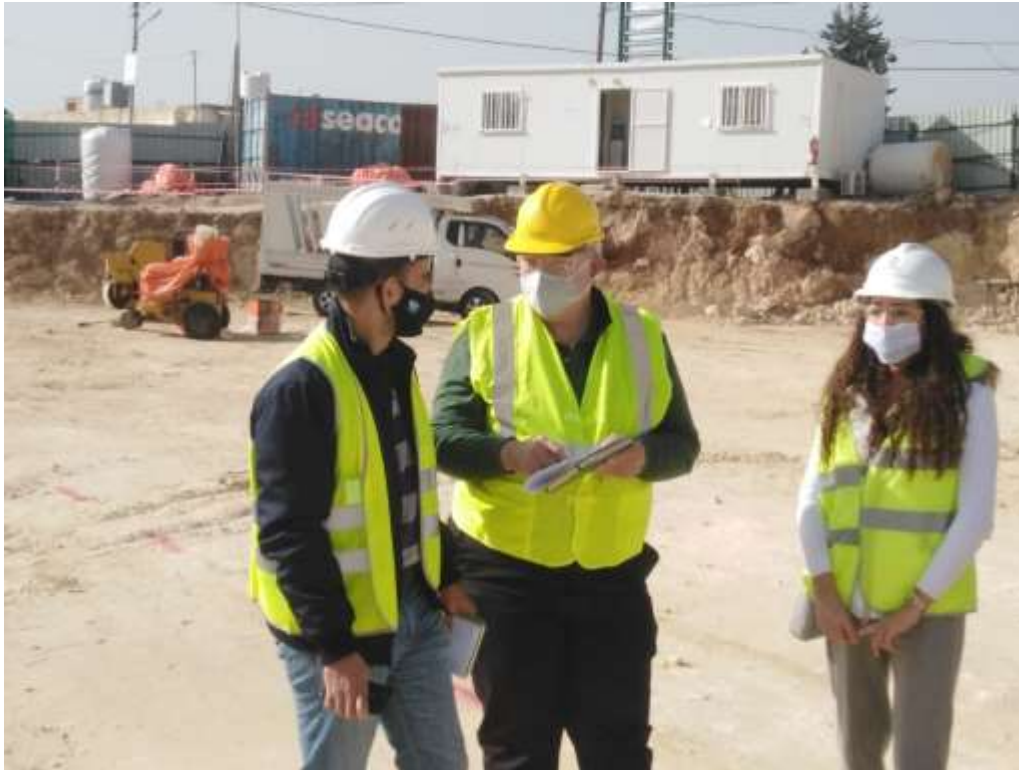
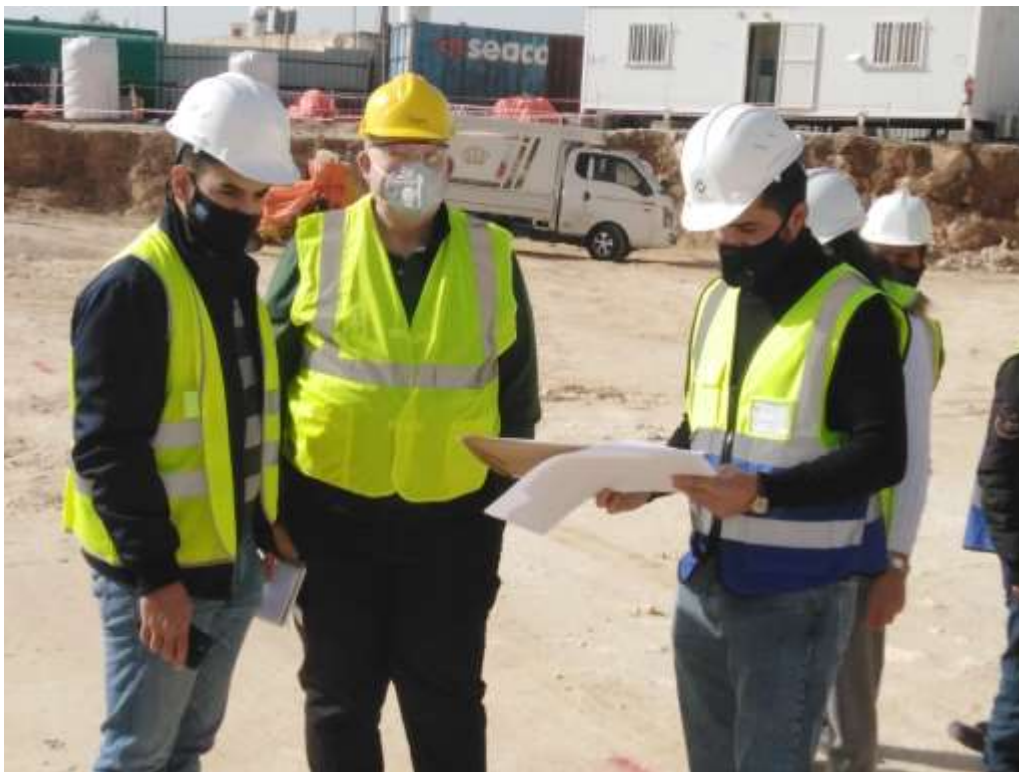
On December 8, 2020 CMTO team visited the site and unfortunately, it was noticed there was no work progress since the last visit CMTO had on November 18, 2020. We expected at least the Plain Concrete under foundation is casted and the preparation for casting the foundations is ongoing. It seems the vertical excavated slope is unsafe and the excavated areas in both sites are in need for further investigations by the Geotech lab..

*FIGURE #02 & 03:
During the site tour of
USAID, CMTO, SE and the
Contractor to check the
drawings and inspect the
excavation works and
unsafe vertical*

- To contact immediately the Geotech engineer to assess and check the current vertical excavated slope.
- The Geotech engineer needs to inform the Contractor and Supervisory if there is any danger to the residential homes and their occupants upslope from the site. If yes, we need a plan on how to address this. This could be serious and may need to be addressed. The construction site is surrounded by three streets in three sides and the Antiquities Department is on the fourth side

- The Geotech Engineer must provide technical report with clear recommendations.
- The Supervisor Engineer will instruct the Contractor to take prompt actions based on the Geotech recommendations in coordination with the MPWH and the SE shall inform USAID and CMTO on the planned steps to be implemented.

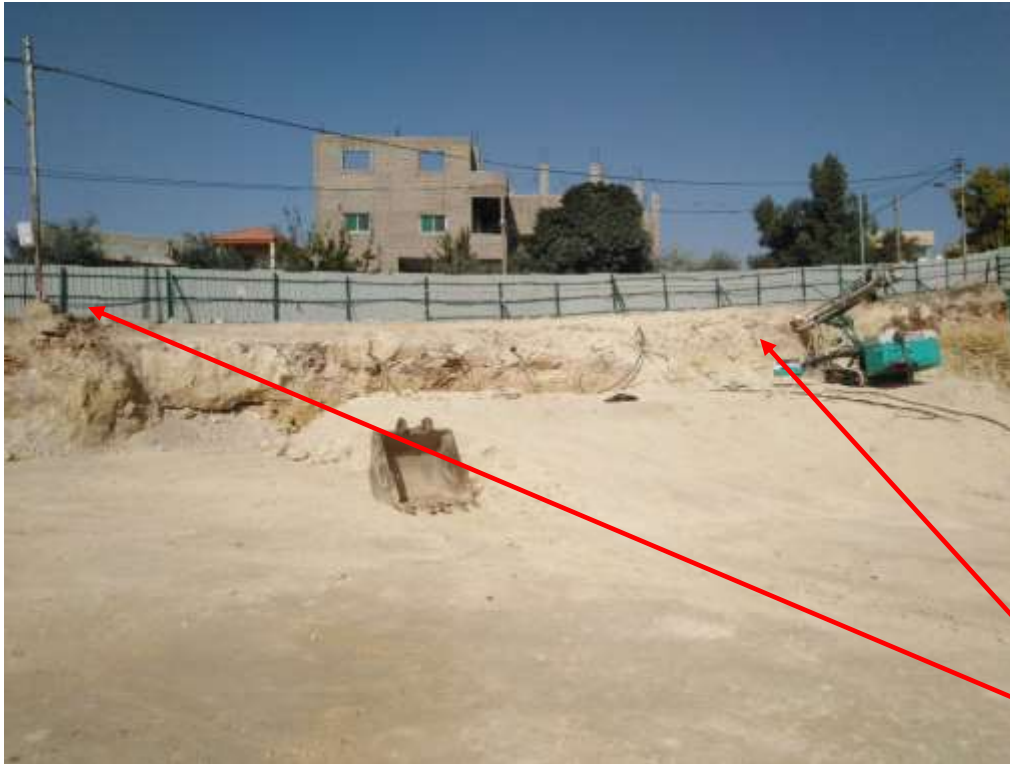
- The existing electrical poles must be supported and protected from soil sliding
- Shoring system started for the area adjacent to the road for protection from any soil slidding and to protect the electricity poles (CMTO recommended on November 18, 2020)

*FIGURE #02 & 03:
Shoringssystem started to
protect the area from soil
sliding and protect the
electricity poles from falling
down*

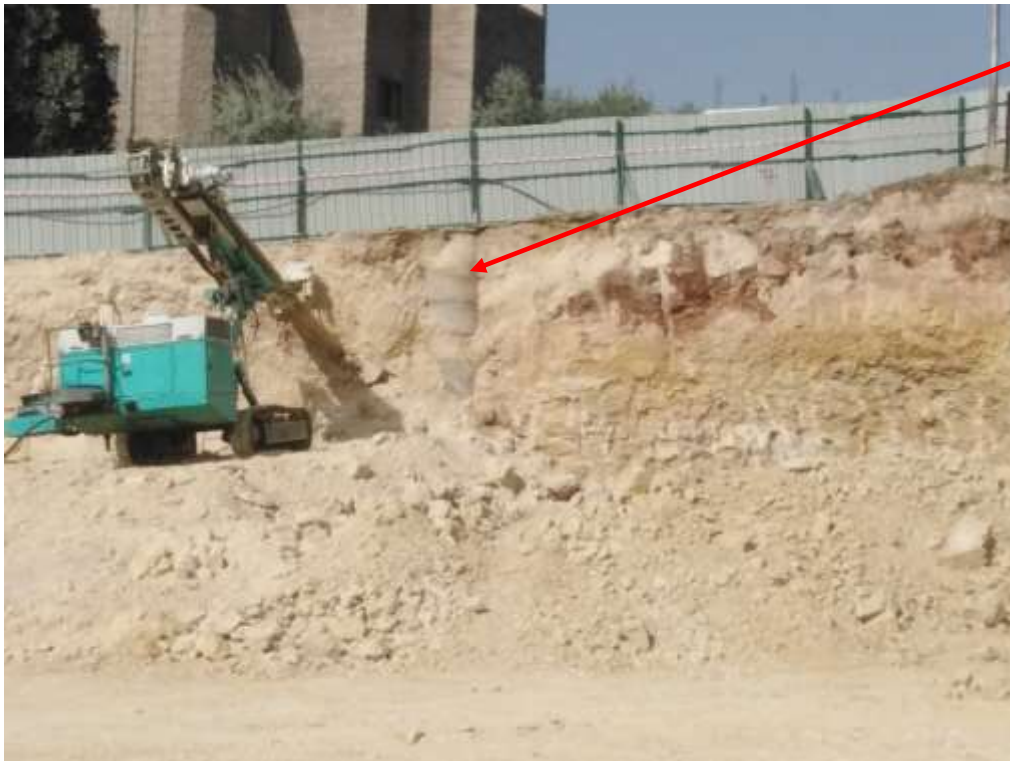
- The excavation works is not completed yet.
- Shoring system is ongoing
- There is an area needs to be checked by Geotechnical lab to determine if it is a cavity or not before starting the construction the retaining walls (see photo)
- There is existing sewage manhole was noticed to area adjacent to road. This area needs to be assessed before starting the construction the retaining walls.

*Existing manhole : The
Contractor must protect the
manhole during the
excavation works*

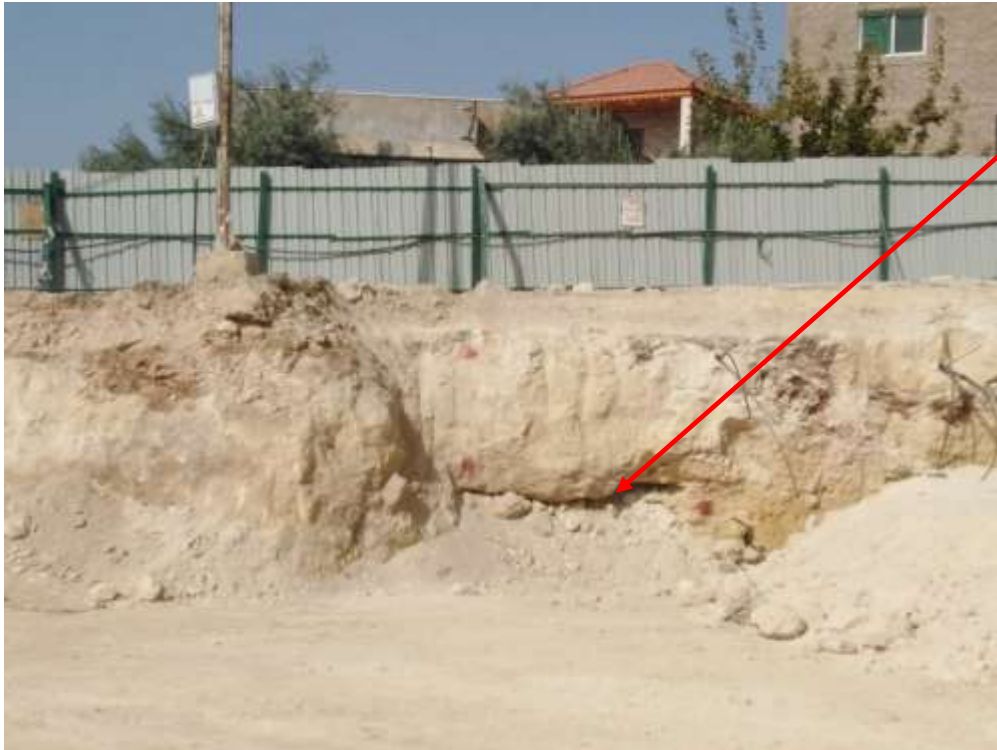
*FIGURE #04:
This area needs to be checked by Geotechnical lab to determine if it is a cavity or not before starting the construction the retaining walls.*

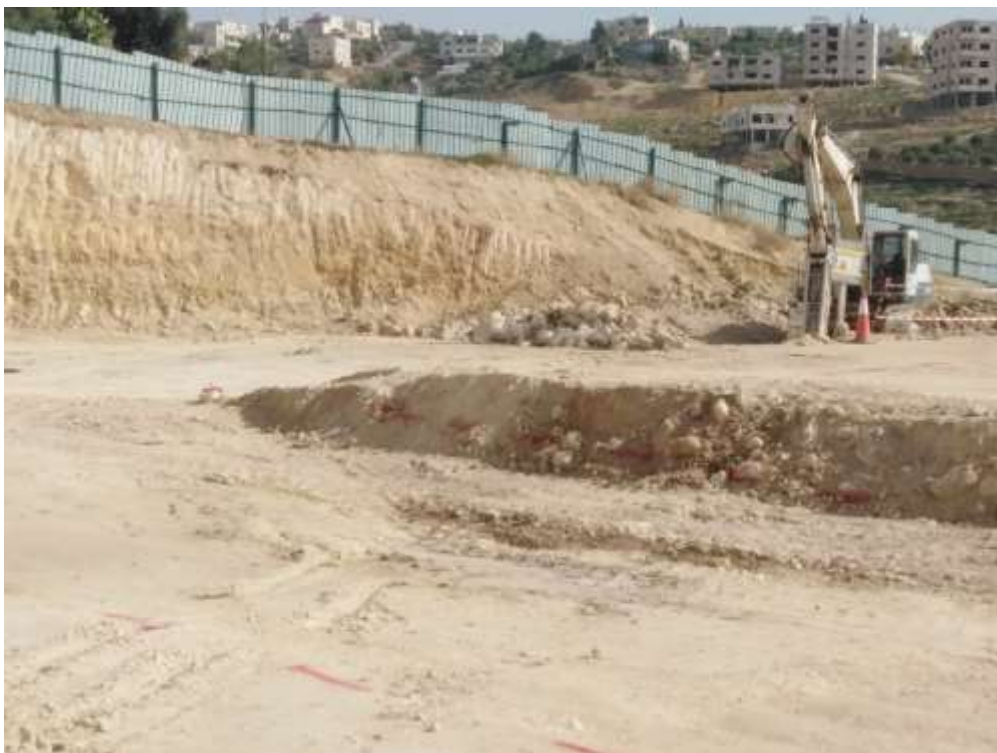
The excavation is stopped till the shoring system is completed

*FIGURE #05:
The excavation works is stopped till completion the shoring system*
